NATIONAL AERONAUTICS AND SPACE ADMINISTRATION

APOLLO 9 MISSION
ANOMALY REPORT NO. 2

LANDING RADAR INTERFERENCE

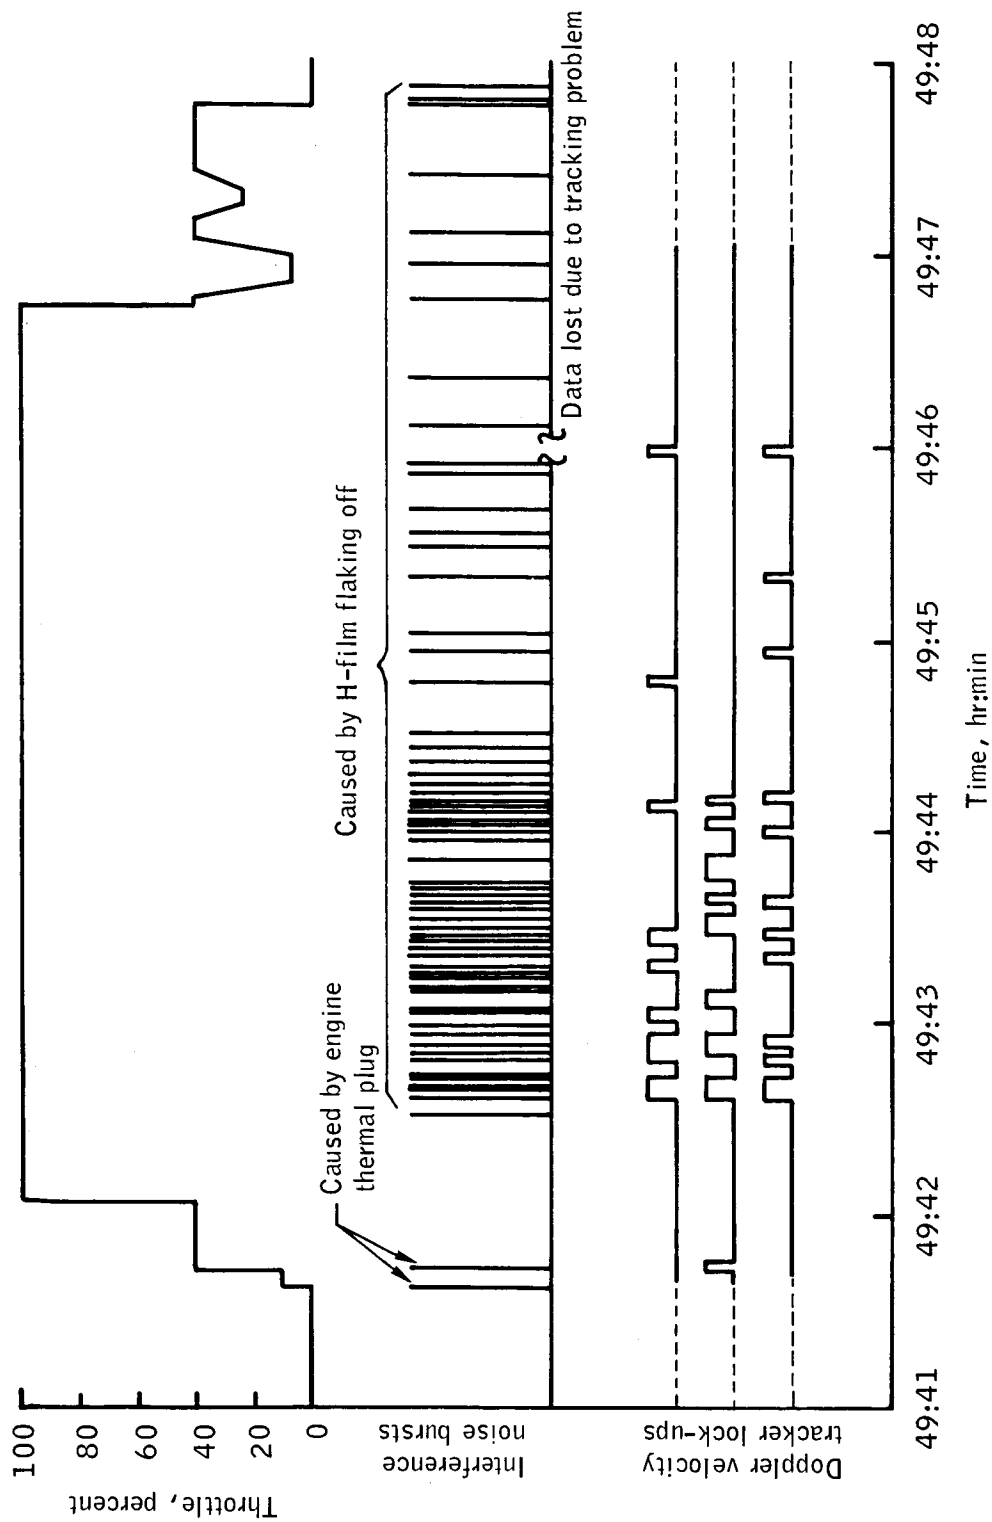
Figure 1.- Landing radar interference.

Figure 1 is a time history of throttle position, interference noise bursts, and Doppler tracker lock-ups. The frequent occurrence of noise bursts beginning at about 30 seconds after reaching full thrust caused three of the four Doppler trackers to lock up, as noted in the lower portion of the figure. The frequency of occurrence of these noise bursts decreased sharply after about 2 minutes, with a corresponding decrease in the number of lock-ups.

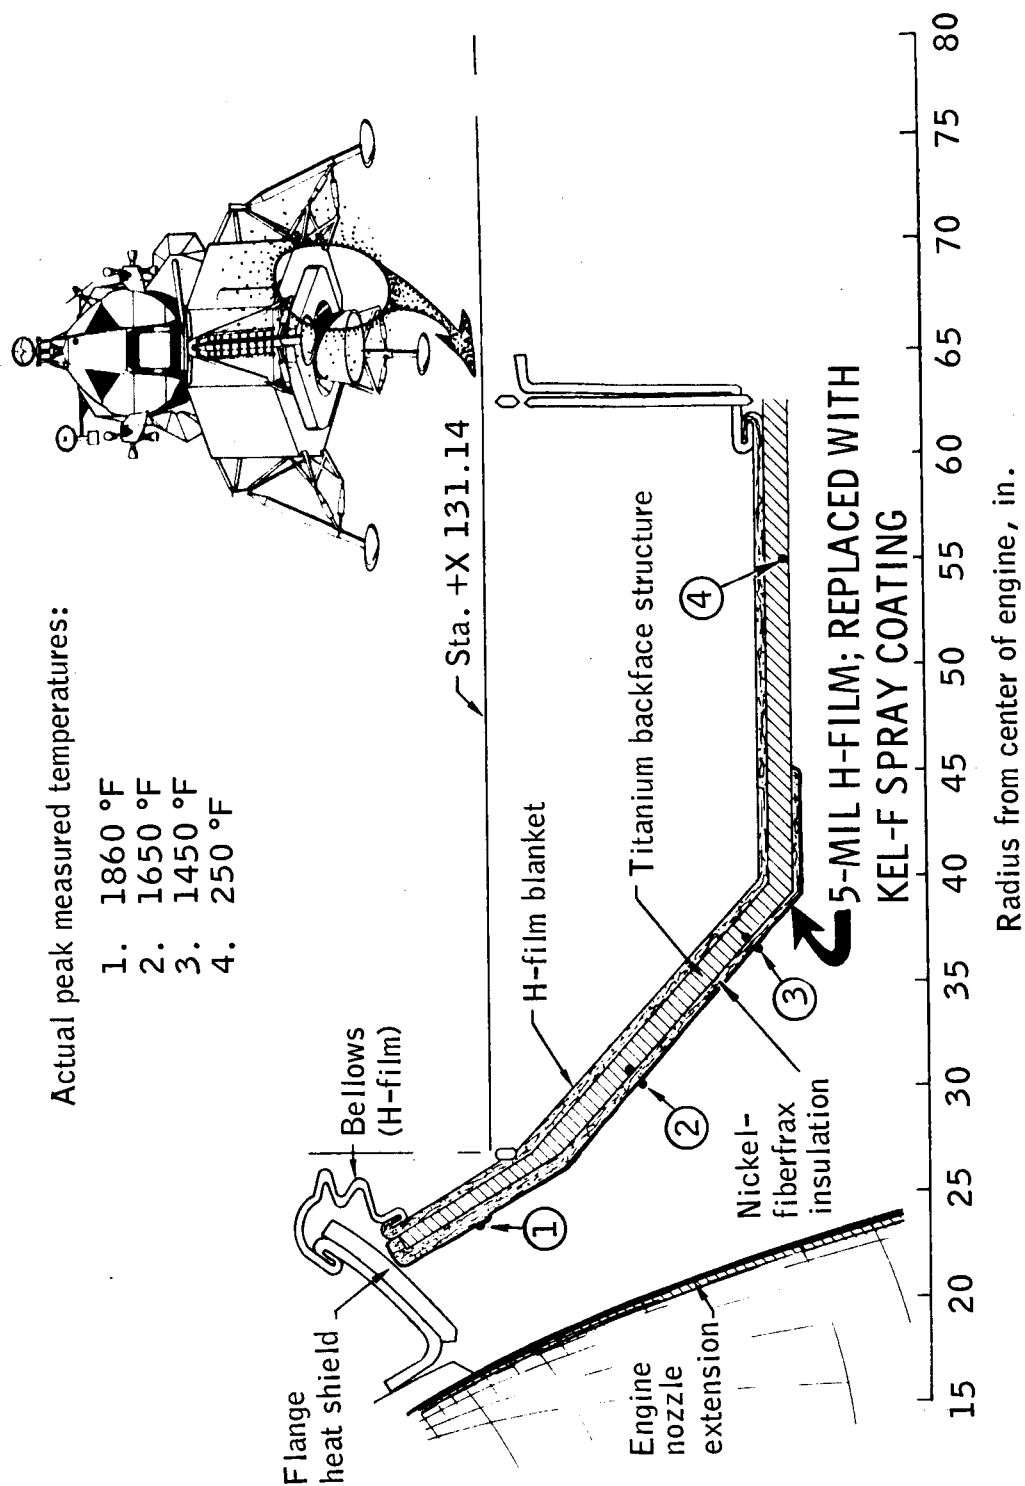
Figure 2.- H-film locations on descent stage base heat shield.

Analysis has shown the noise bursts were caused by flaking of the aluminized H-film installed on the base heat shield of the descent stage. The H-film, used to limit solar heating of the descent stage during trans-lunar coast, is taped to the base heat shield in an overlapping fashion. At temperatures above 800° F, the tape adhesive degrades and allows the sheets to flake off. A cross-section of the H-film installation and the actual temperatures experienced at four points are shown in figure 2. A photograph of the installed film is shown in figure 3. The flakes of H-film, as they break away and traverse the radar beams, act as small reflectors. Their relative motion therefore appears as a velocity to the landing radar and causes lock-up of the Doppler trackers.

Pieces of H-film from the base heat shield and the thrust-chamber plug for the descent engine acted as reflectors in the landing radar beams and caused interfering noise bursts in the velocity sensing electronics. Interference produced by the heat-shield H-film would be damaging to the performance of the landing radar during an actual descent to the lunar surface. Interference resulting from the jettisoned thrust-chamber plug is predictable and of very brief duration and therefore not considered a problem.

A spray coating of KEL-F plastic was found to have acceptable surface and thermal characteristics at the temperatures involved, and this coating sublimates rather than flakes. Since this spray coating offers the same thermal protection to the base heat shield, it has been substituted for the H-film on Apollo 11 and subsequent missions. No corrective action involving the thrust-chamber plug is required.

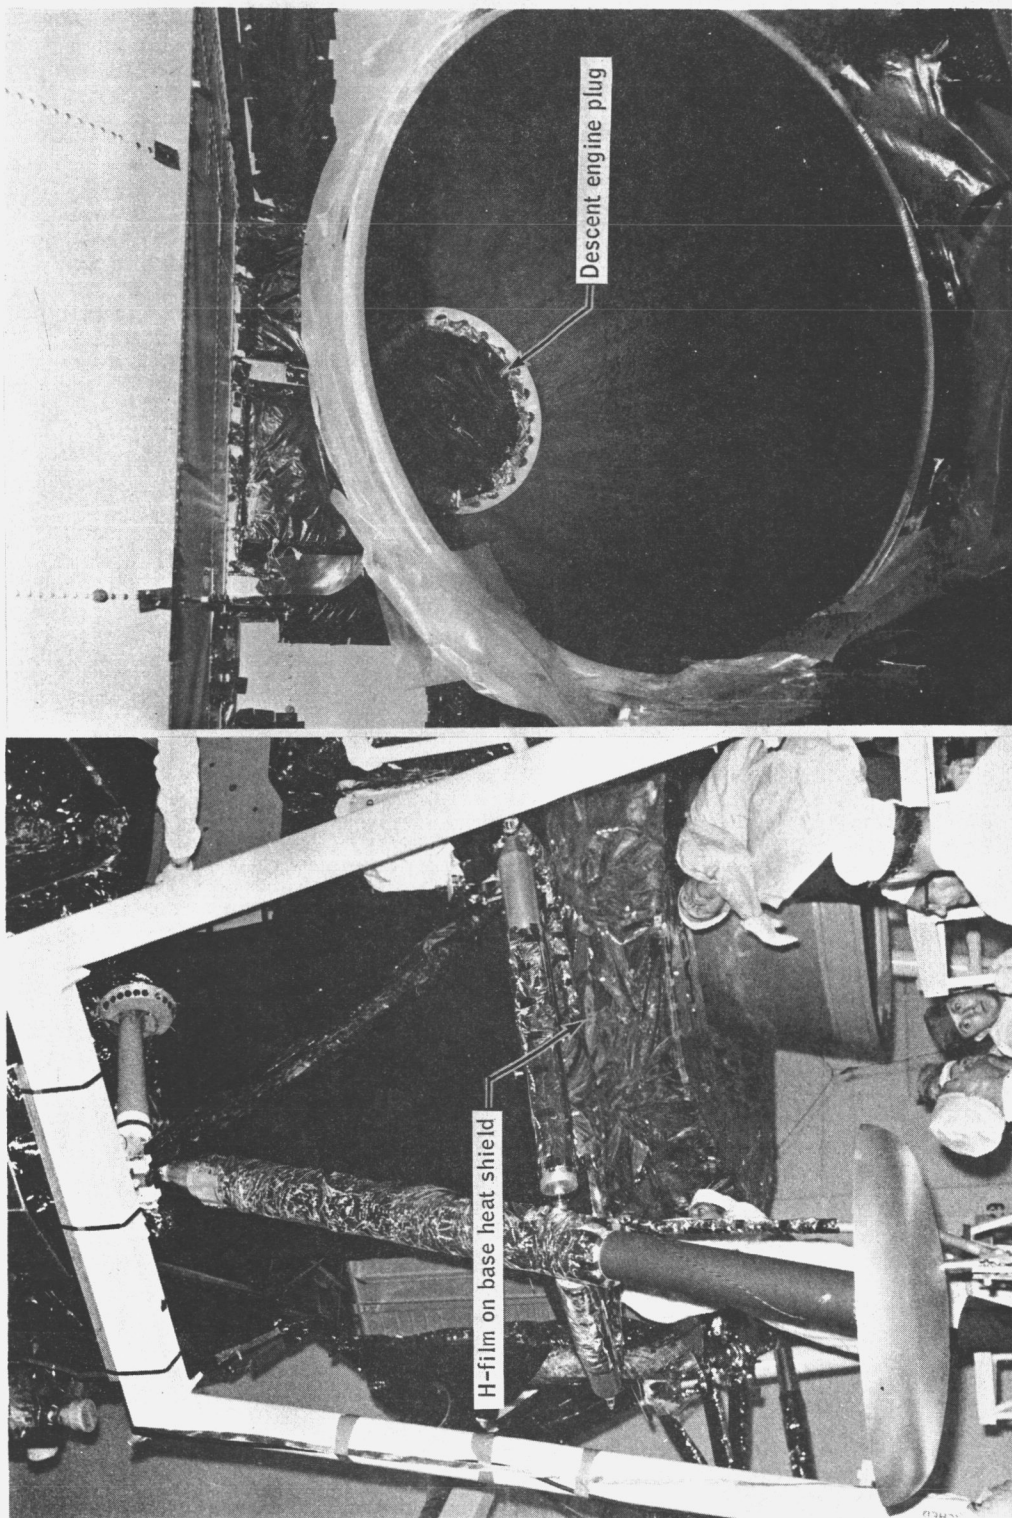
Figure 3.- H-film installations.

Interference noise bursts were also noted during the period of initial thrusting from 10 to 40 percent which coincided with discharge of the descent engine thrust-chamber plug. This plug consisted of five sheets of aluminized H-film 0.5-mil thick and was installed (see fig. 3) to limit engine injector heat loss during translunar coast. As shown in figure 2, only one lock-up was experienced from the interference produced by the jettisoned plug.
